Meeting regarding the Former J.H. Baxter Arlington Facility
March 23, 2015 10-12 AM

EPA Meeting

J.H. Baxter Arlington

Chem-Ox Study

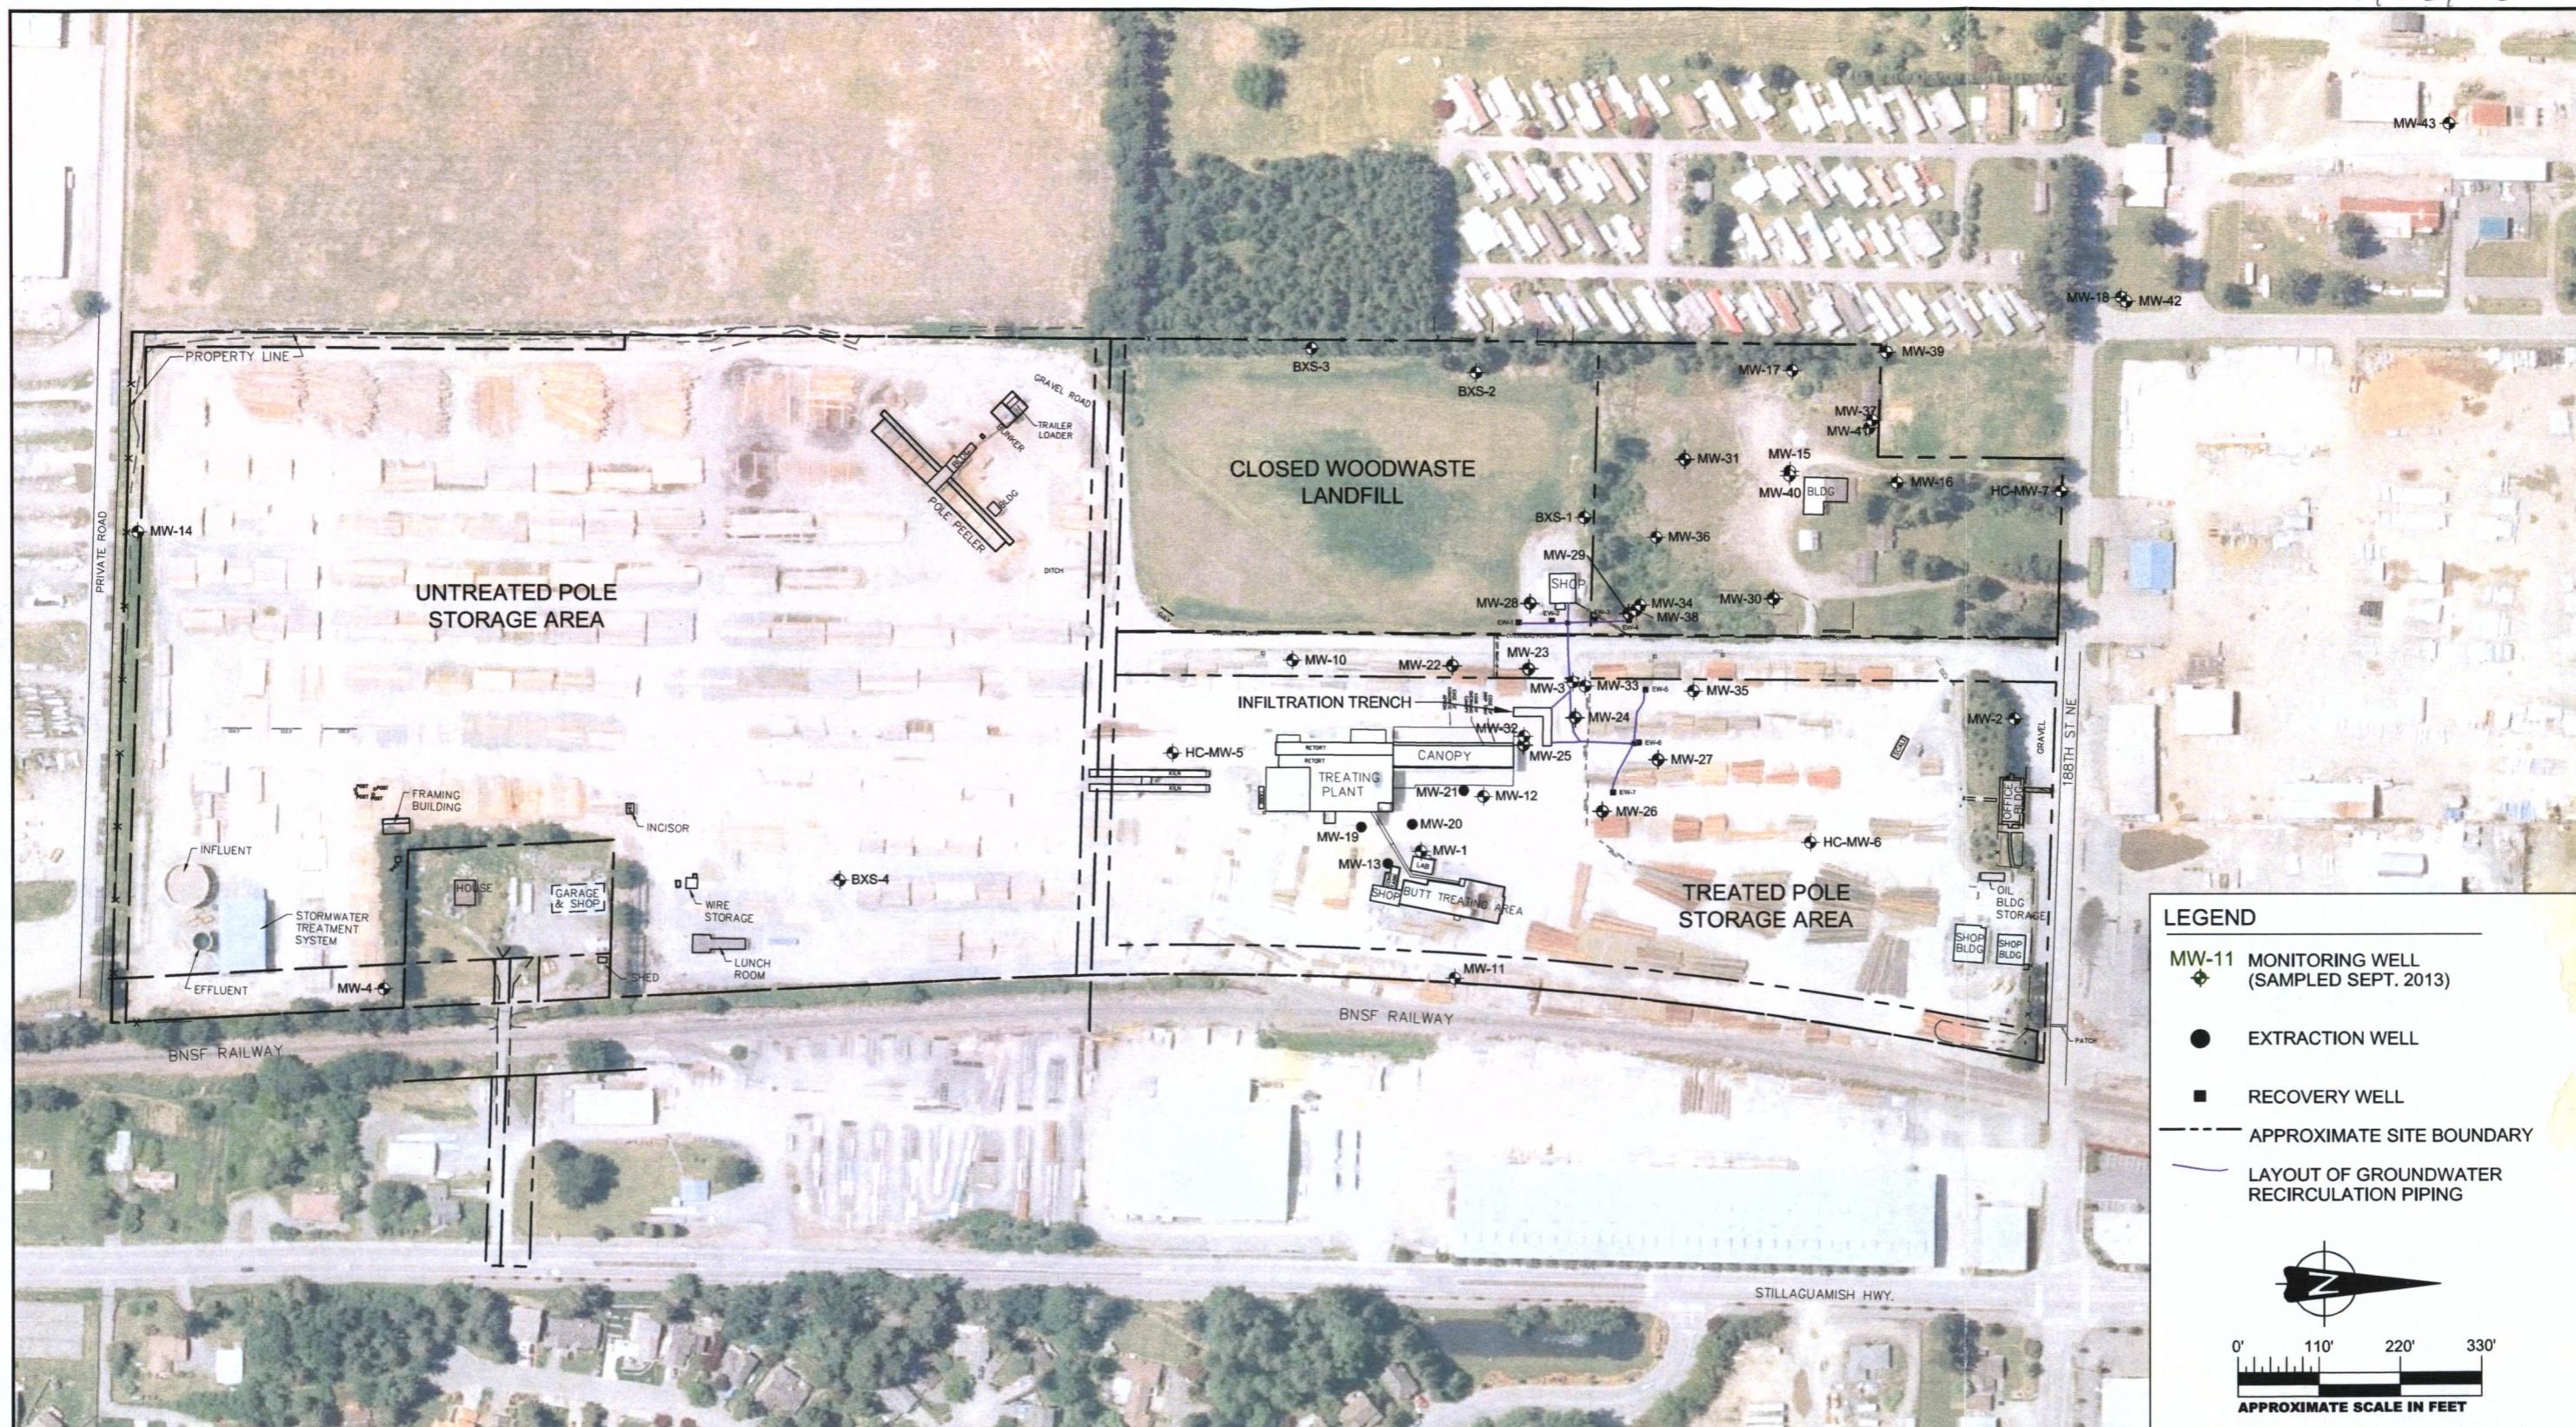
AERIAL: MAY 2009, GOOGLE	CLIENT: J.H. BAXTER	DWN BY: APS/SD	PROJECT: FORMER J.H. BAXTER AND CO. WOOD TREATING FACILITY ARLINGTON, WA	DATE: NOVEMBER 2014
		CHK'D BY: JS		PROJECT NO.: 4-61M-125612
		DATUM:		REV. NO.: A
		PROJECTION:		FIGURE NO.: 2
		SCALE: AS SHOWN	SITE PLAN & GROUNDWATER MONITORING NETWORK

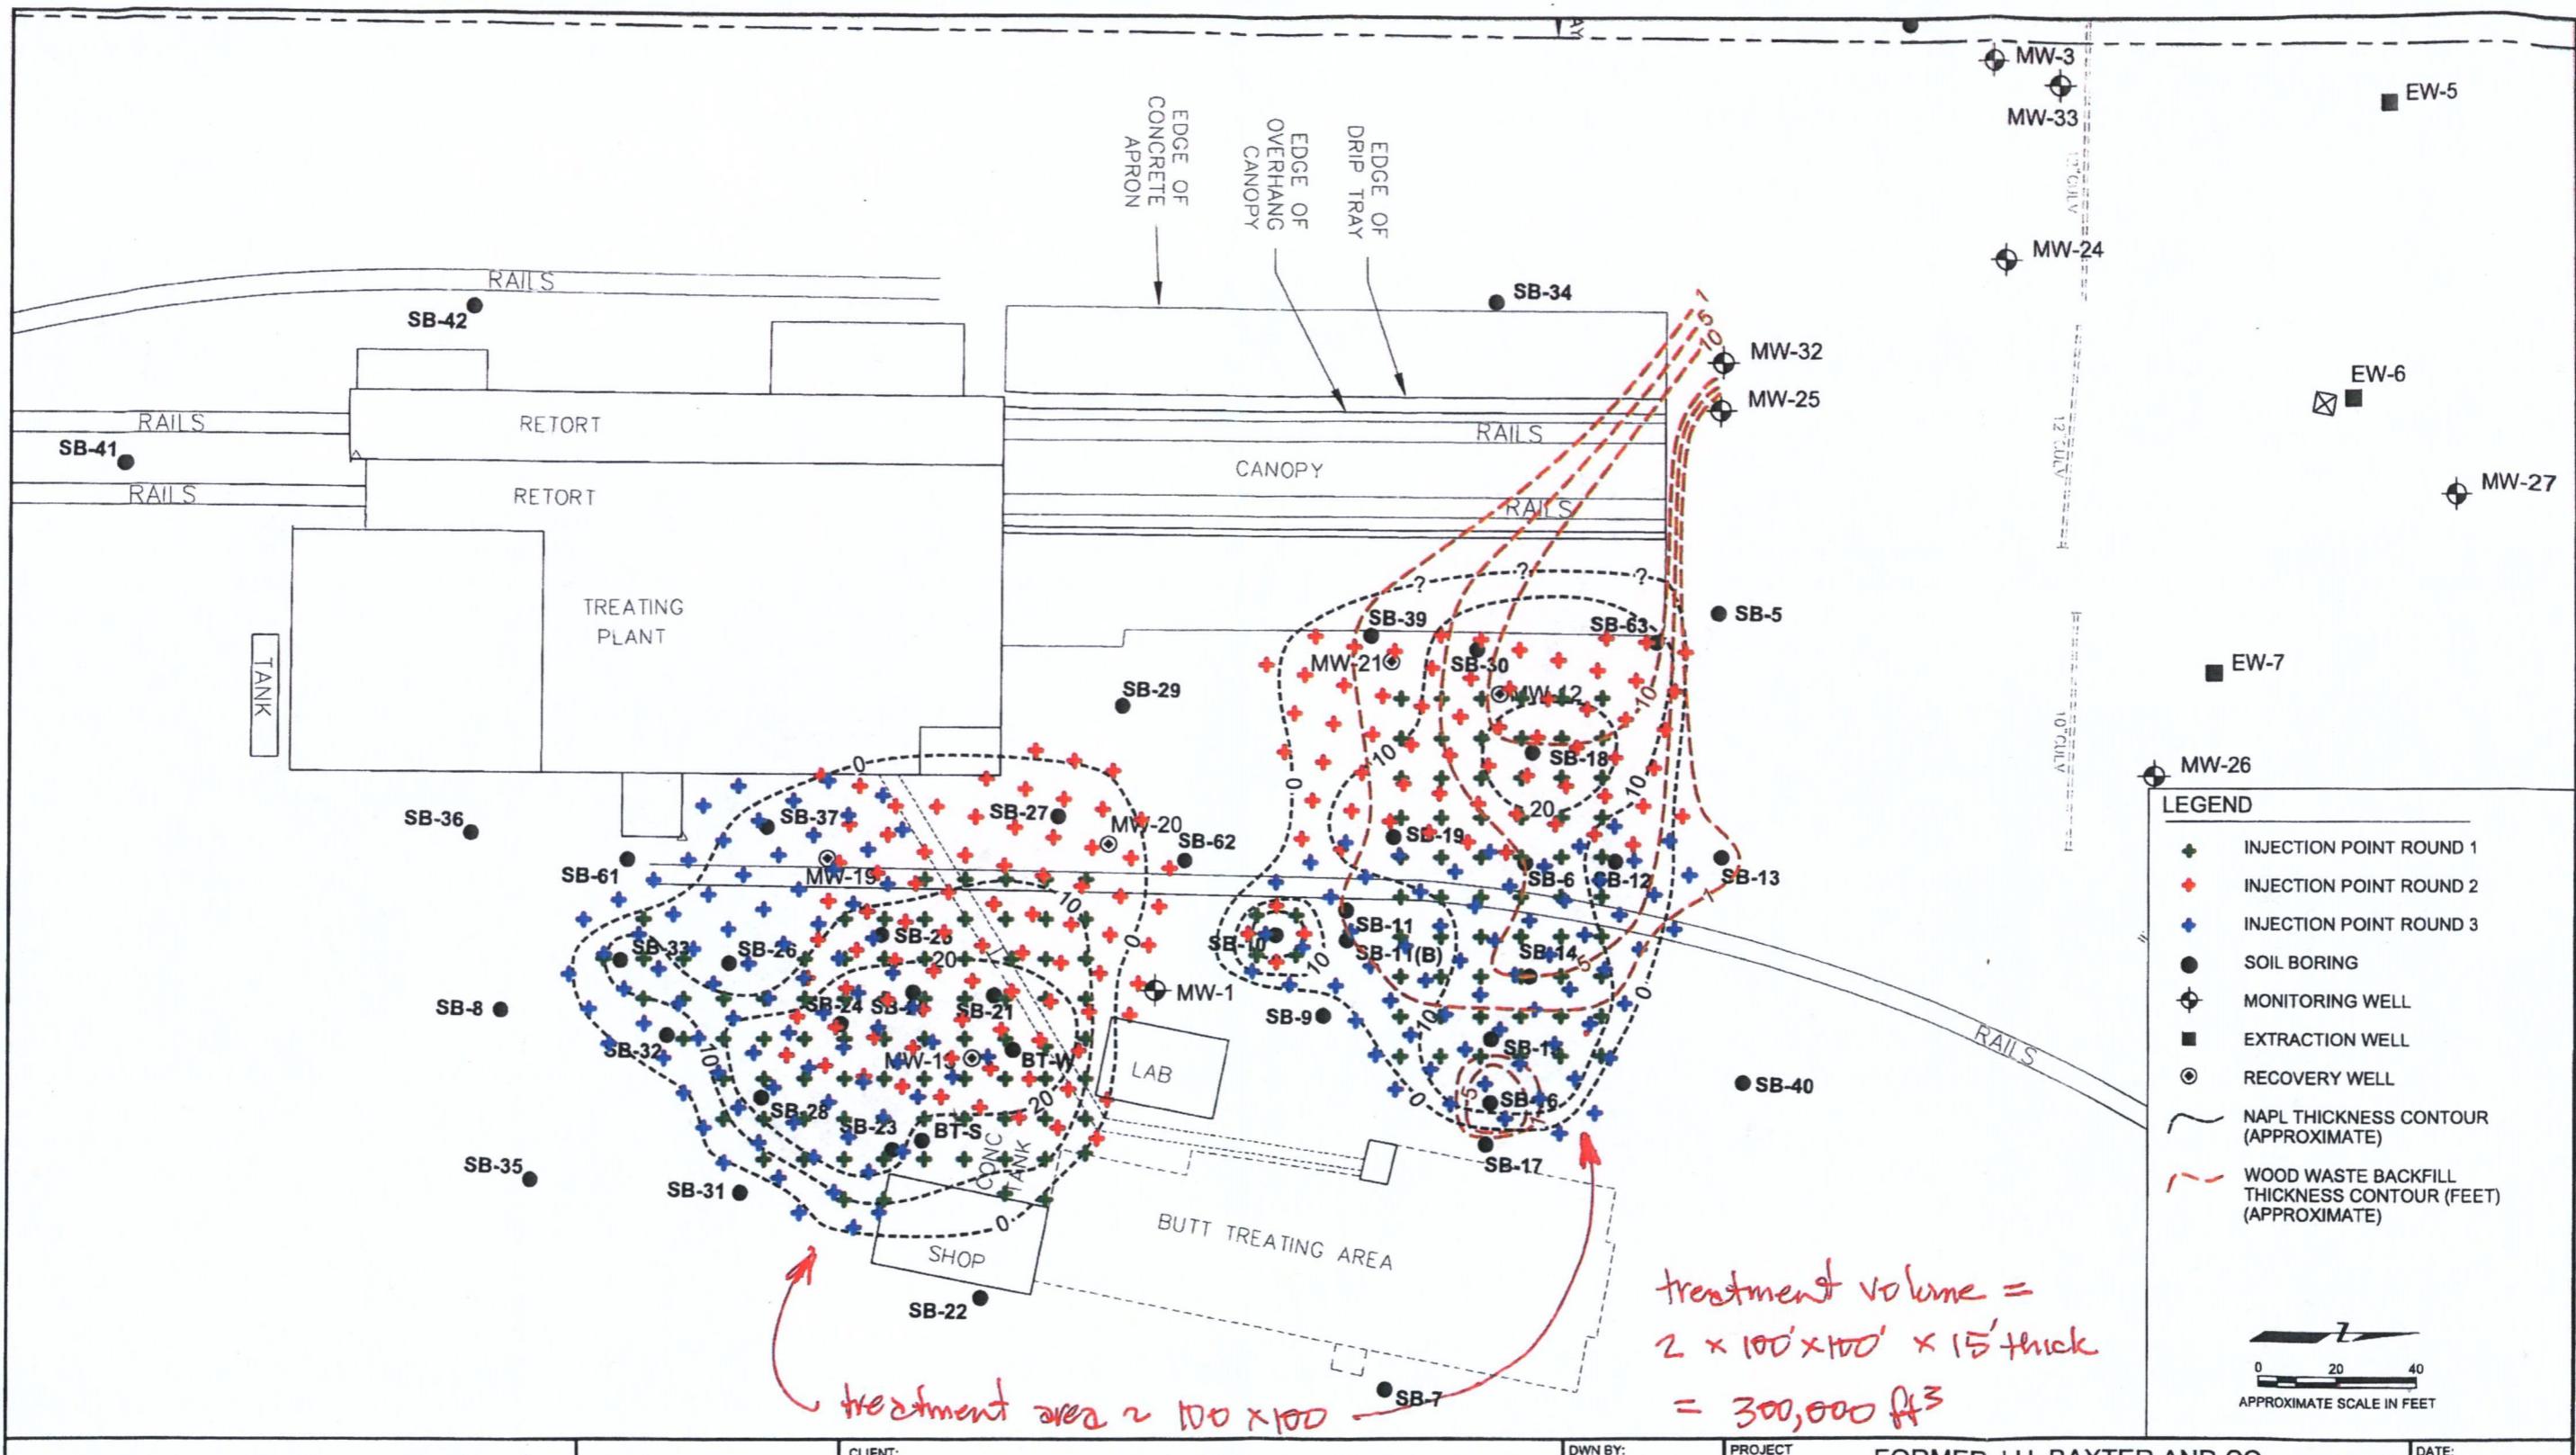
FIGURE No. 9-6

CLIENT: J.H. BAXTER	DWN BY: APS	PROJECT FORMER J.H. BAXTER AND CO. WOOD TREATING FACILITY ARLINGTON, WA	DATE: MARCH 2013
		CHK'D BY: SB	TITLE ALTERNATIVE 6 CHEMICAL OXIDATION AND ENHANCED BIODEGRADATION RECIRCULATION	PROJECT NO: 3-61M-125611
	AMEC 7376 S.W. Durham Road Portland, OR. U.S.A. 97224	DATUM: - PROJECTION: - SCALE: AS SHOWN	REV. NO.: A

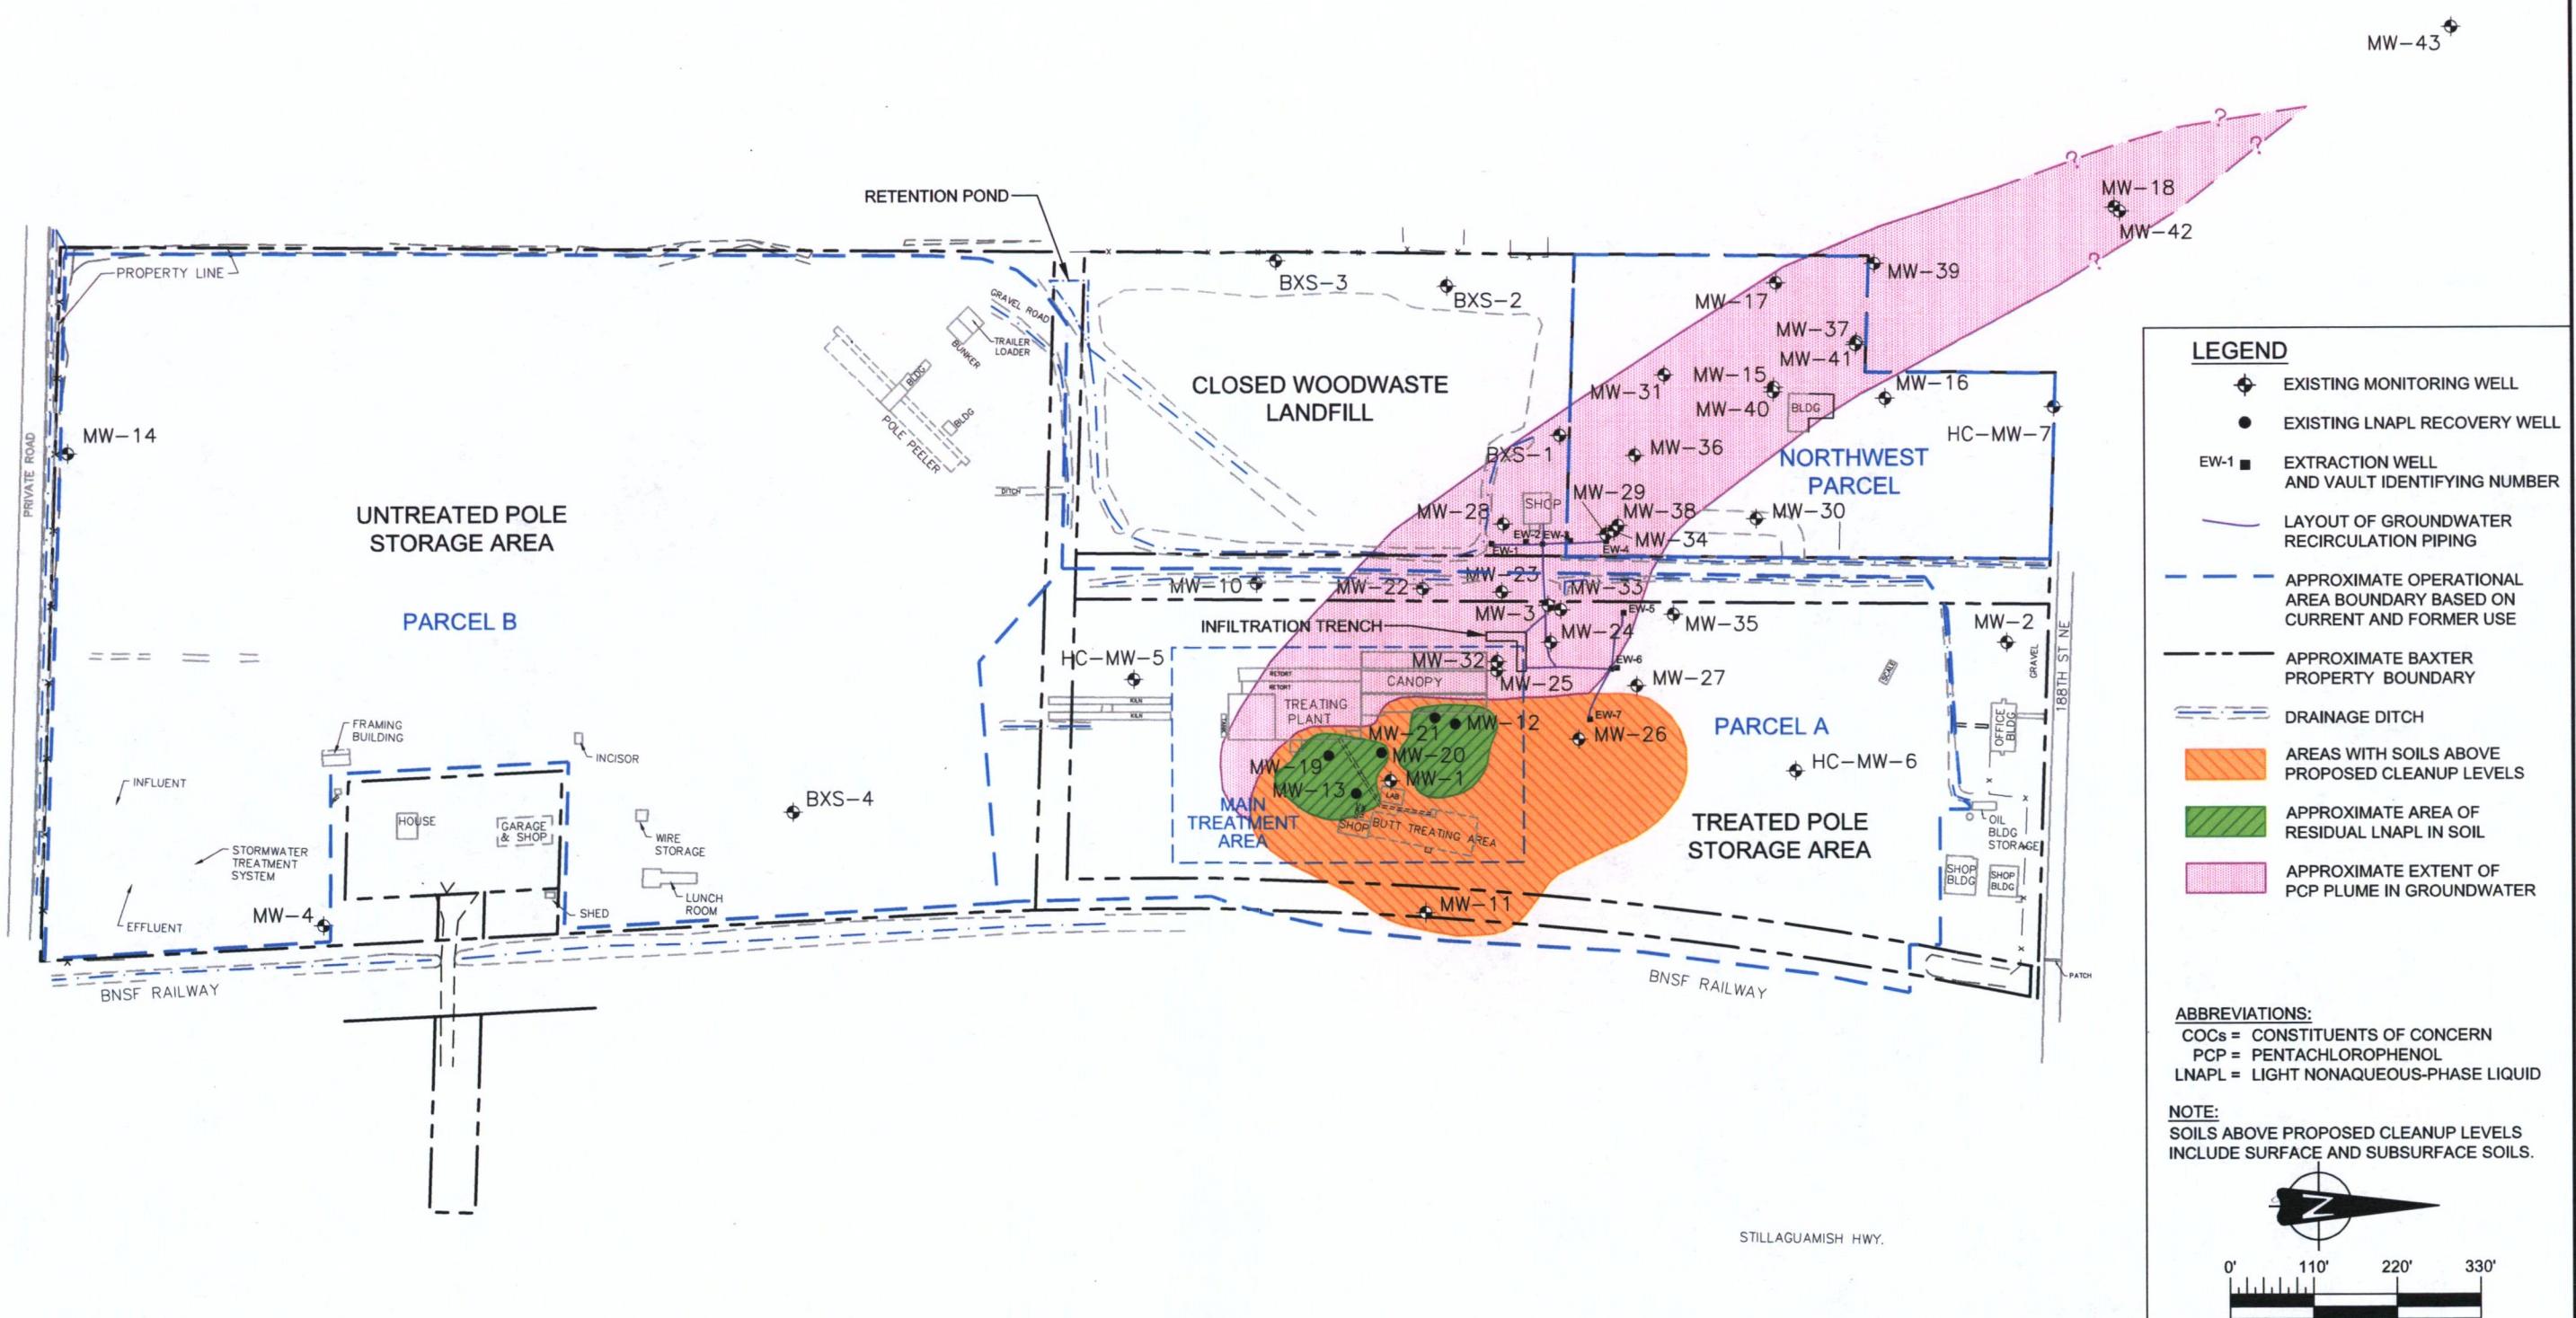
FIGURE No.
3

AREAS OF CONCERN

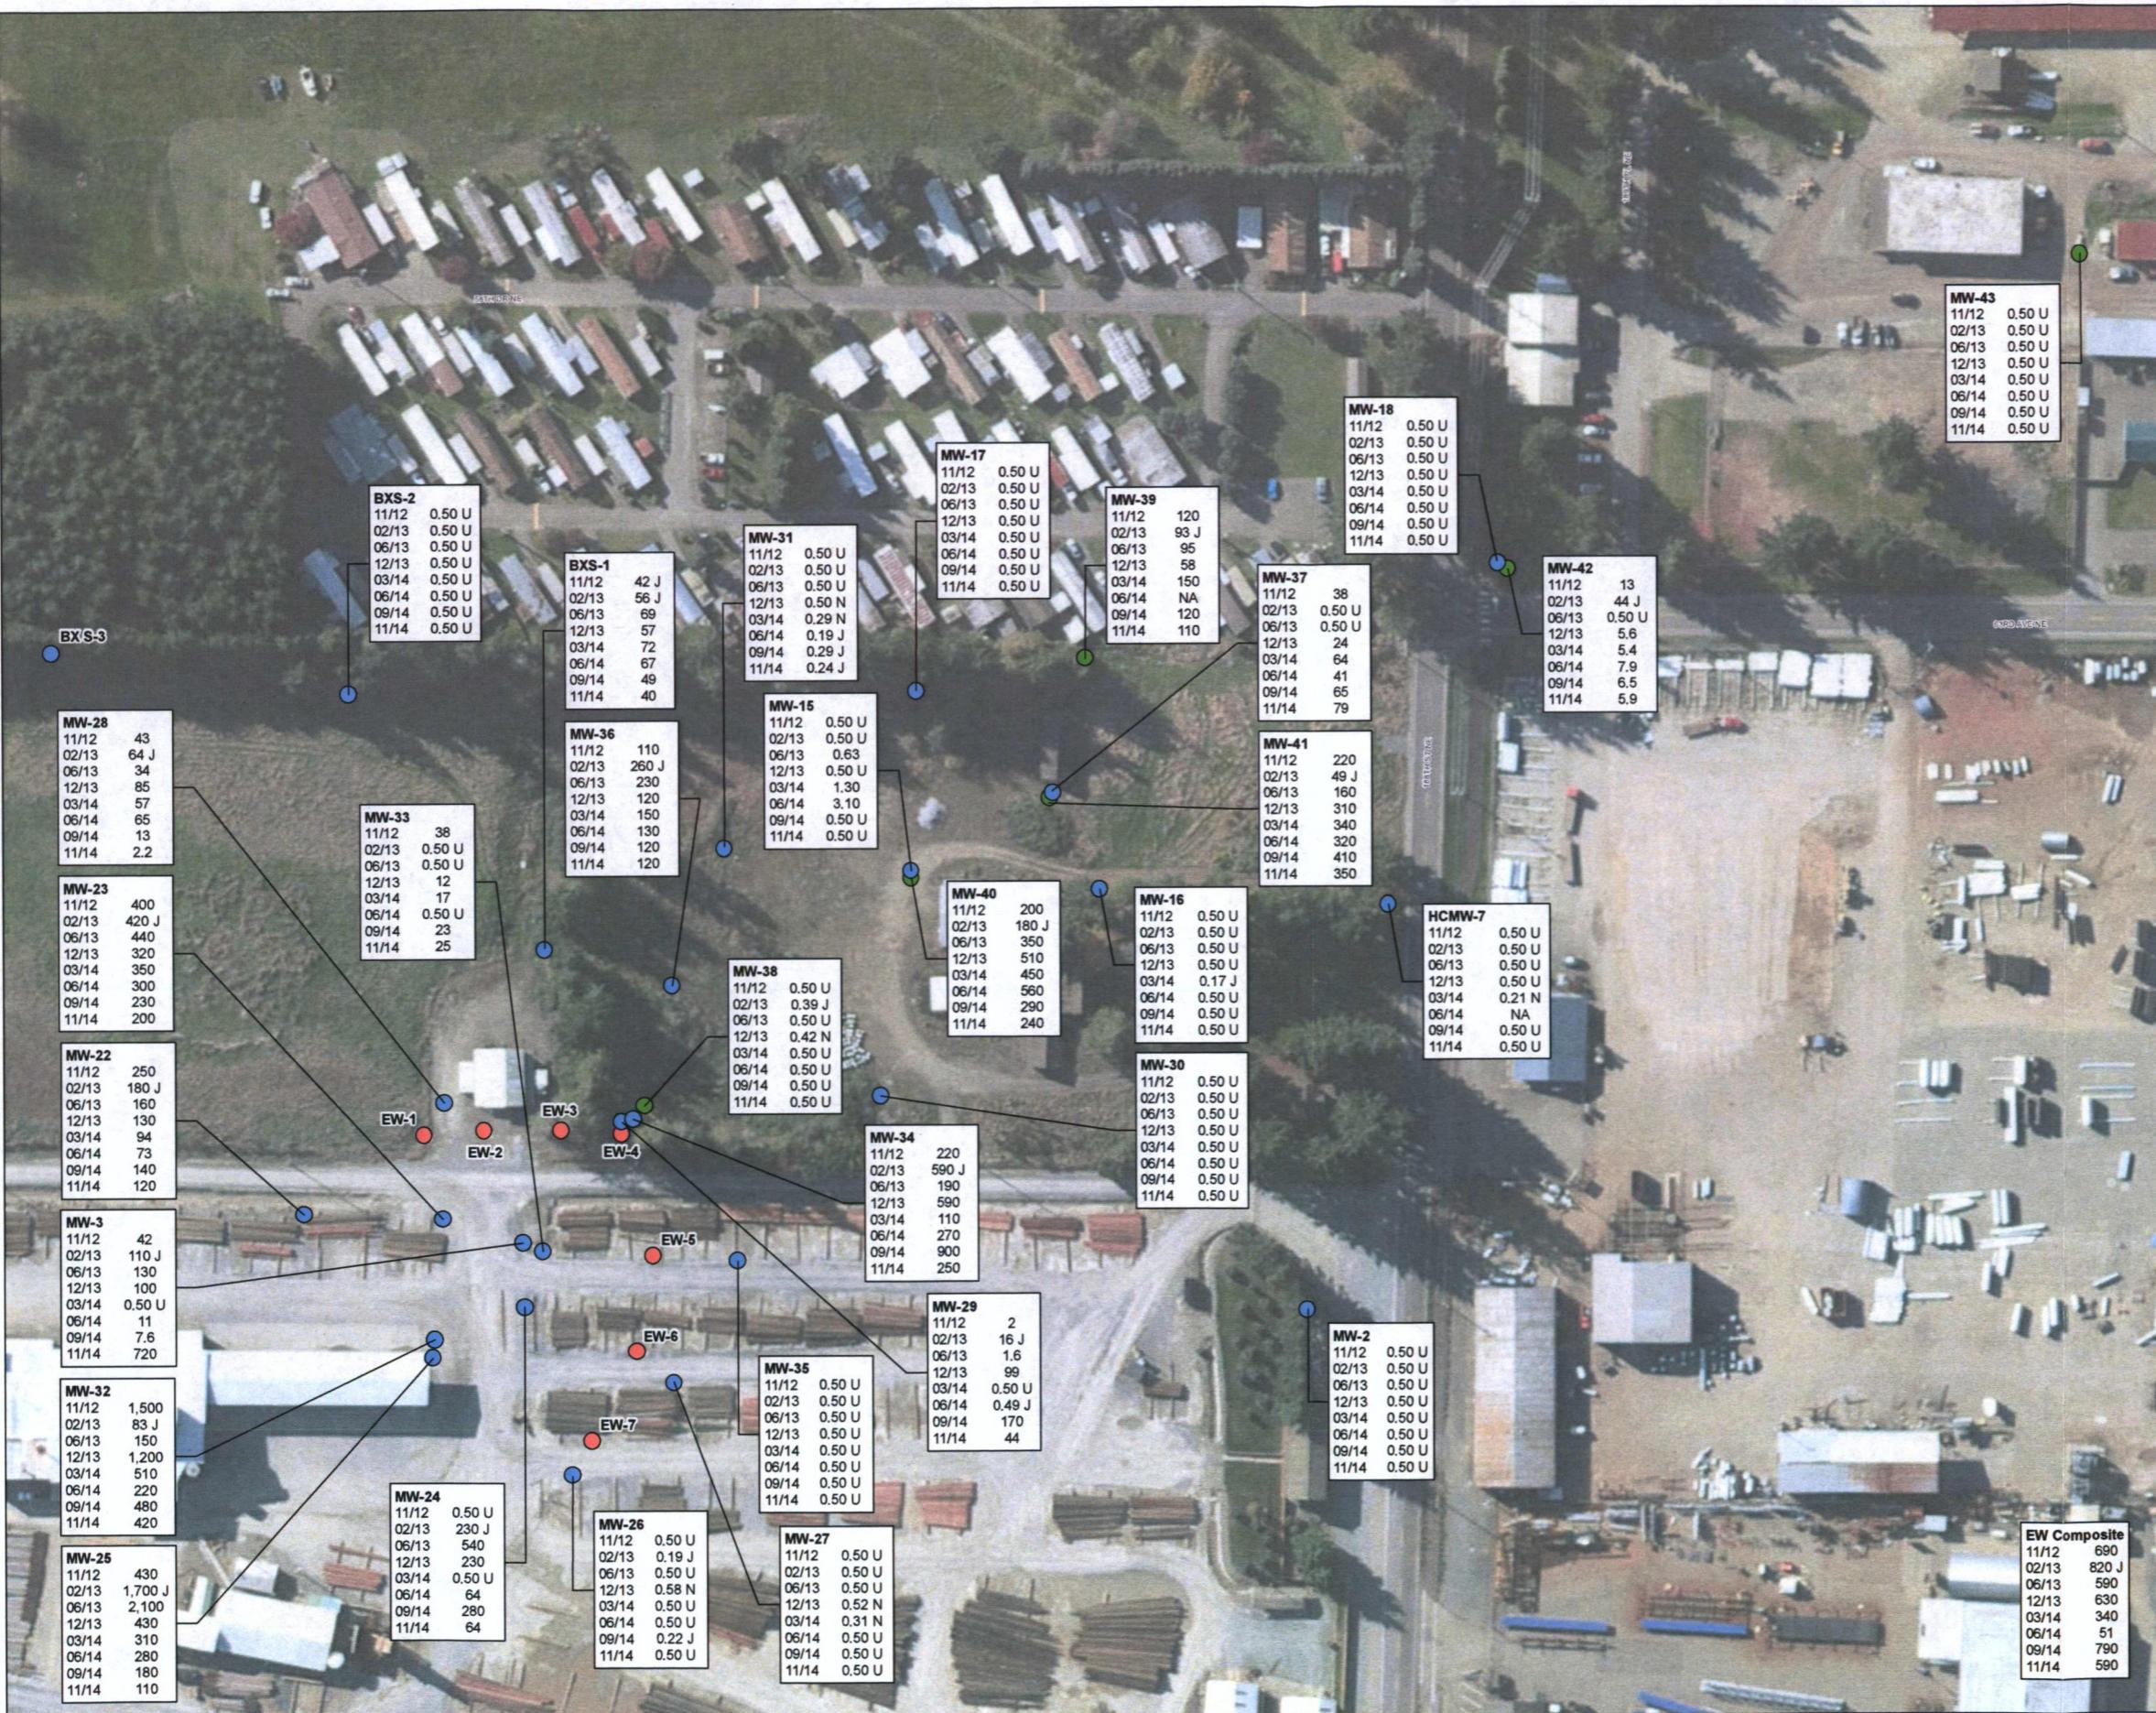
FIGURE 7

Pentachlorophenol in Groundwater:
Fourth Quarter 2012 - Fourth Quarter 2014

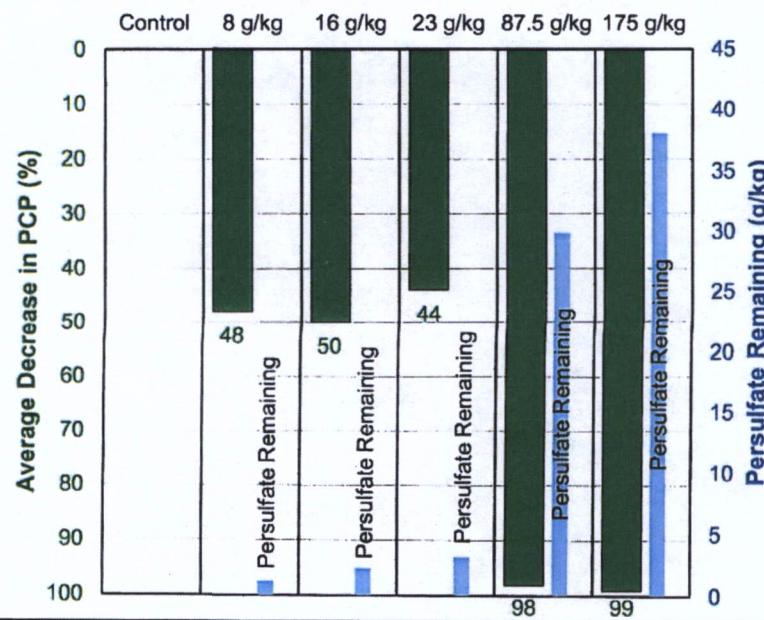
Sample SB-A: 24-27

Persulfate Dose	Average % Decrease in PCP	Persulfate Remaining (g/kg)
Control	0	0
8 g/kg	48	1.2
16 g/kg	50	2.2
23 g/kg	44	3.2
87.5 g/kg	98	29.9
175 g/kg	99	38.1

Sample SB-A: 24-27 Summary of Bench Oxidation Effectiveness Testing at Day 49

- Dosed at 8, 16, and 23 g/kg using alkaline persulfate
- Findings:
- Effective usage of the persulfate best at about 23 g/kg achieving approximately 50% reduction in PCP mass
- To achieve higher reduction in mass, significant oxidant remains unused
- Review Figure 7

Figure 7
Pentachlorophenol (PCP) Oxidized vs Persulfate Used
at Day 49
Former J.H. Baxter Co. Wood Treating Facility
Arlington, Washington

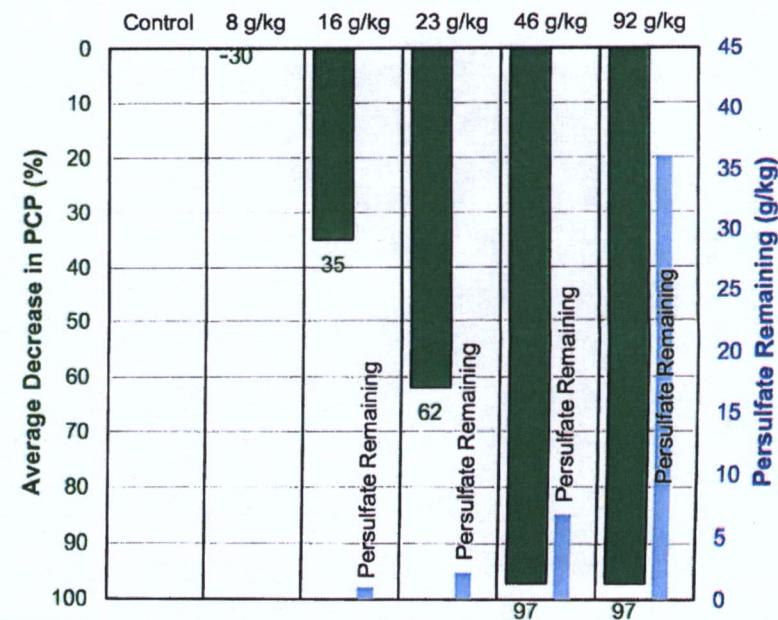
Sample SB-D: 30-33

Persulfate Dose	Average % Decrease in PCP	Persulfate Remaining (g/kg)
Control	0	0
8 g/kg	-30	0
16 g/kg	35	1
23 g/kg	62	2.2
46 g/kg	97	6.8
92 g/kg	97	36.1

Sample SB-D: 30-33 Summary of Bench Oxidation Effectiveness Testing at Day 49

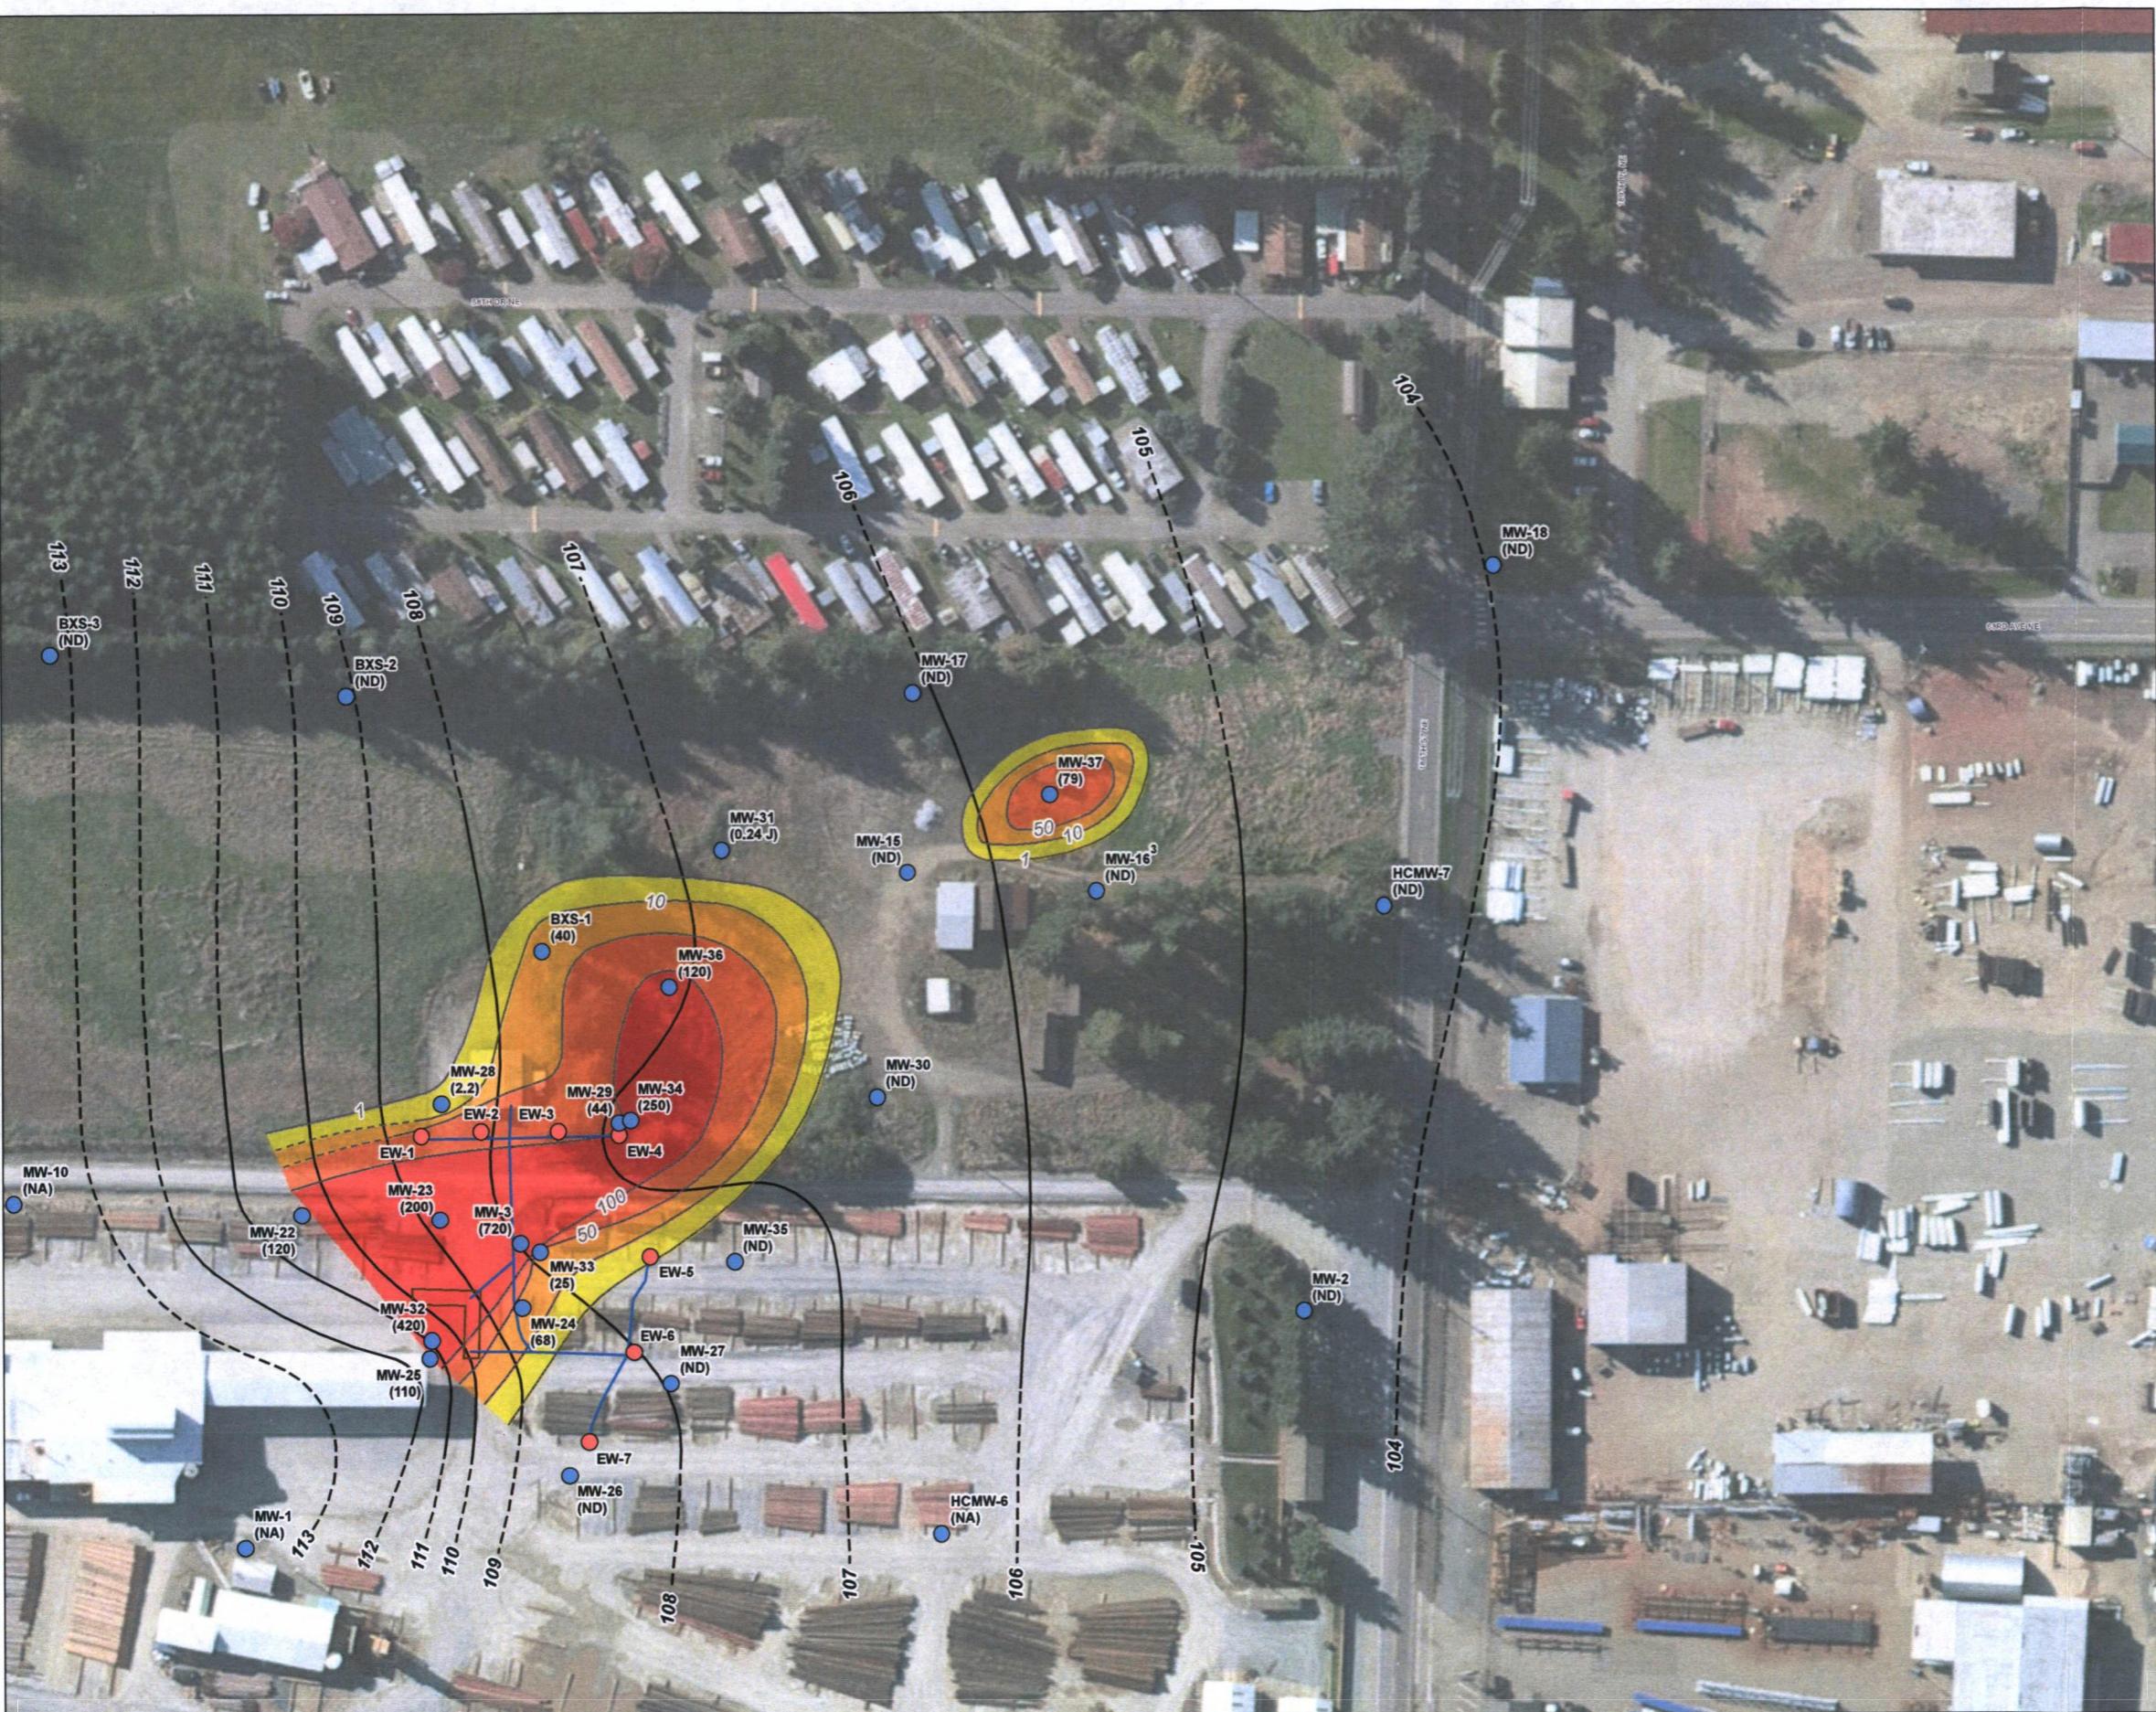
FIGURE 15

Pentachlorophenol Isopleth Map:
Fourth Quarter 2014

- Subsurface is amenable to aerobic biodegradation of PCP
- Chem-ox bench scale showed that 7 times that amount of persulfate as was estimated in the FS would be required to remove approximately 50% of the mass (up to 1 million lbs of persulfate)
- If attempt to remove additional mass; residual persulfate would remain unused
- Current system is accelerating aerobic degradation
 - Present of bacteria that degrade PCP aerobically
 - review PCP plume maps
